PIER 5
PRELIMINARY STUDY

Prepared for:
Pier 5 Association

Prepared by:
DeSimone Consulting Engineers

November 19, 2021

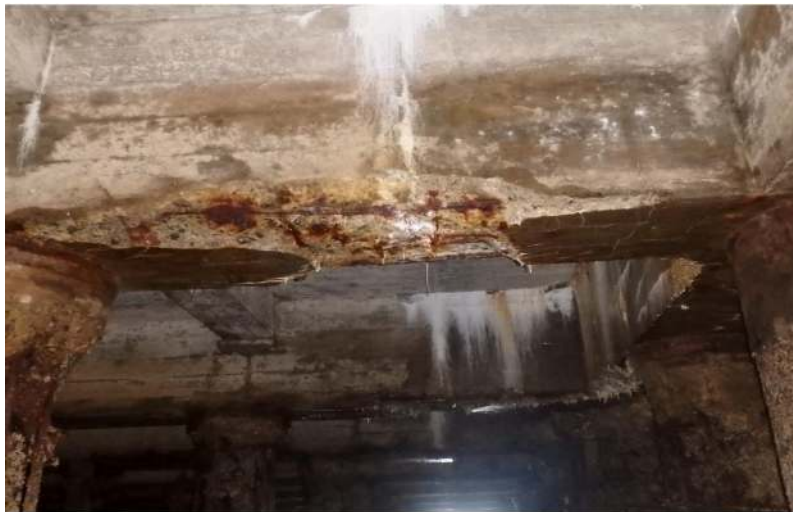
Predictably, the lack of maintenance through the years led to progressively worse deterioration in all pier elements as noted in subsequent reports from 2000 prepared by Fay, Spofford and Thorndike, and from 2004 and 2017, performed by Childs Engineering Corporation. The most recent report notes that the full loss of weld at pile splices and severe metal loss at portions of the piles have greatly reduced, if not fully reduced, the capacity of some piles. Furthermore, it has been noted that corrosion of the reinforcing steel within the concrete deck and pile caps has begun to accelerate causing substantial concrete spalling on the underside of the pier.

Figure 3-Corrosion and Spalling at Underside of Pier (Courtesy of Childs Report)

Per previous reports, various asphalt patches and steel cover plates have been used as patchwork surface remediations throughout the years. All coverings would need to be removed down to the original concrete which would need to be inspected for any significant corrosion or spalling that would reduce the load carrying capacity. Locations of sever degradation would require removal of existing concrete to sound substrate, prepping and/or replacing corroded reinforcing and patching the area.

It is assumed that the underside of the deck has seen substantially more corrosion and thus may require substantially more repairs to the point that full depth replacement may be a more viable and cost-effective solution. An elevated walkway that is independently supported by the pile caps currently spaced at 6' to 12' o/c would provide an alternate solution to repairing the deck.

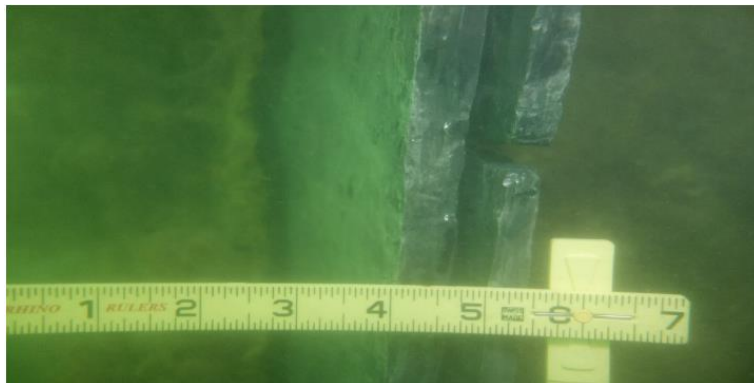
It appears that the pier remained abandoned after the Yard's closure until the first of several periodic inspections by Childs Engineering Corporation in 1987. That report noted substantial deterioration of the protective concrete pile encasement and of the welds around the exposed pile splices. Corrosion of the steel piles was also noted, while the concrete deck and pile caps were generally noted to be in good condition.

Figure 4-Deterioration at Pile Splice (Courtesy of Childs Report)

As discussed earlier, it is assumed that the capacity of the existing piles is approaching a level that cannot safely support additional load. Piles needing to be replaced will need to have the splices re-welded and any sections with significant section loss will need to be repaired. After the steel pile is adequately repaired, the pile should be encased in concrete for future protection. Similar to the pile caps, it may be feasible to only have to repair every other pile in a given area depending on the final design loading. For example, at the typical areas of the pier (not at the existing tracks) it is likely feasible to only repair every other pile along the transverse sections. Likewise heavier loads such as planters could likely be accommodated where the tracks were located by only having to repair every other pile. Necessary investigations would need to verify the ability of the pile caps to span the additional distance between supporting piles as a result.

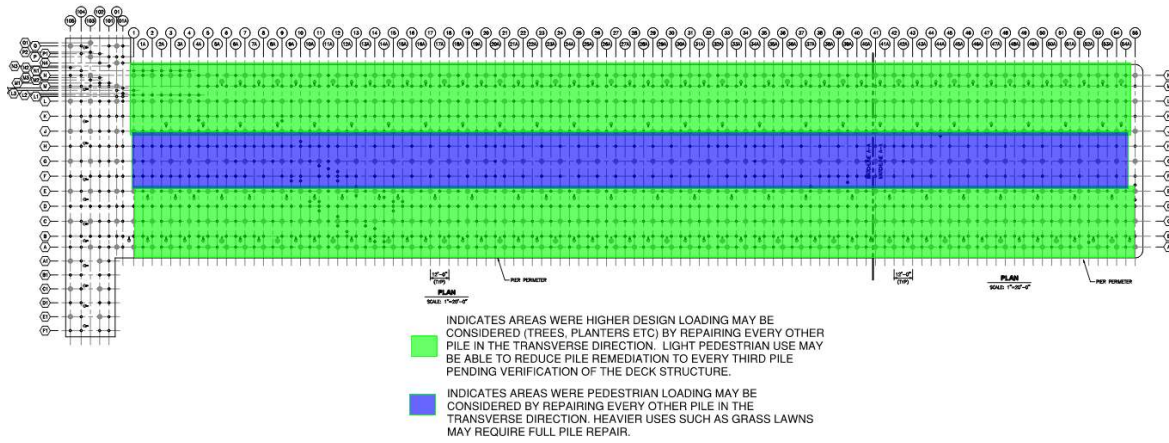
Figure 6-Representative Pile Repair Diagram (Pier Layout taken from Childs Report)
