PIER 5
PRELIMINARY STUDY

Prepared for:
Pier 5 Association

Prepared by:
DeSimone Consulting Engineers

November 19, 2021

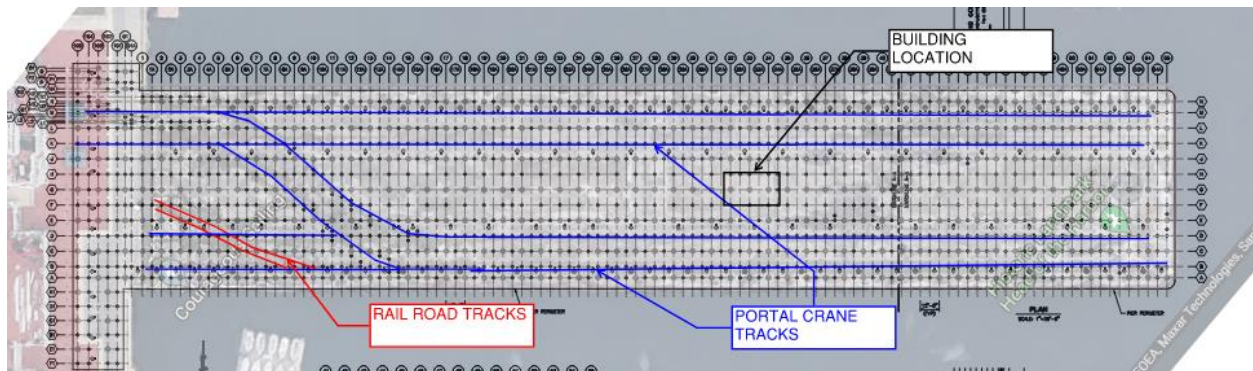
Figure 5-Pier Diagram (Layout taken from Child's Report)

Based on the information listed above, we have calculated the self-weight of the pier structure (slab and pile caps) to be approximately 255 pounds per square foot. Given the assumed original live load and the indicated pile spacing, the estimated original design loading on each pile was approximately 40 Tons, which is validated by the pile capacity indicated above. These capacities are further validated by considering the additional weight of the portal cranes in comparison to the more closely spaced piles supporting the existing tracks.
